# **Meter cleaning & a new internal coating**

June 10, 2026 – CEESI Conference

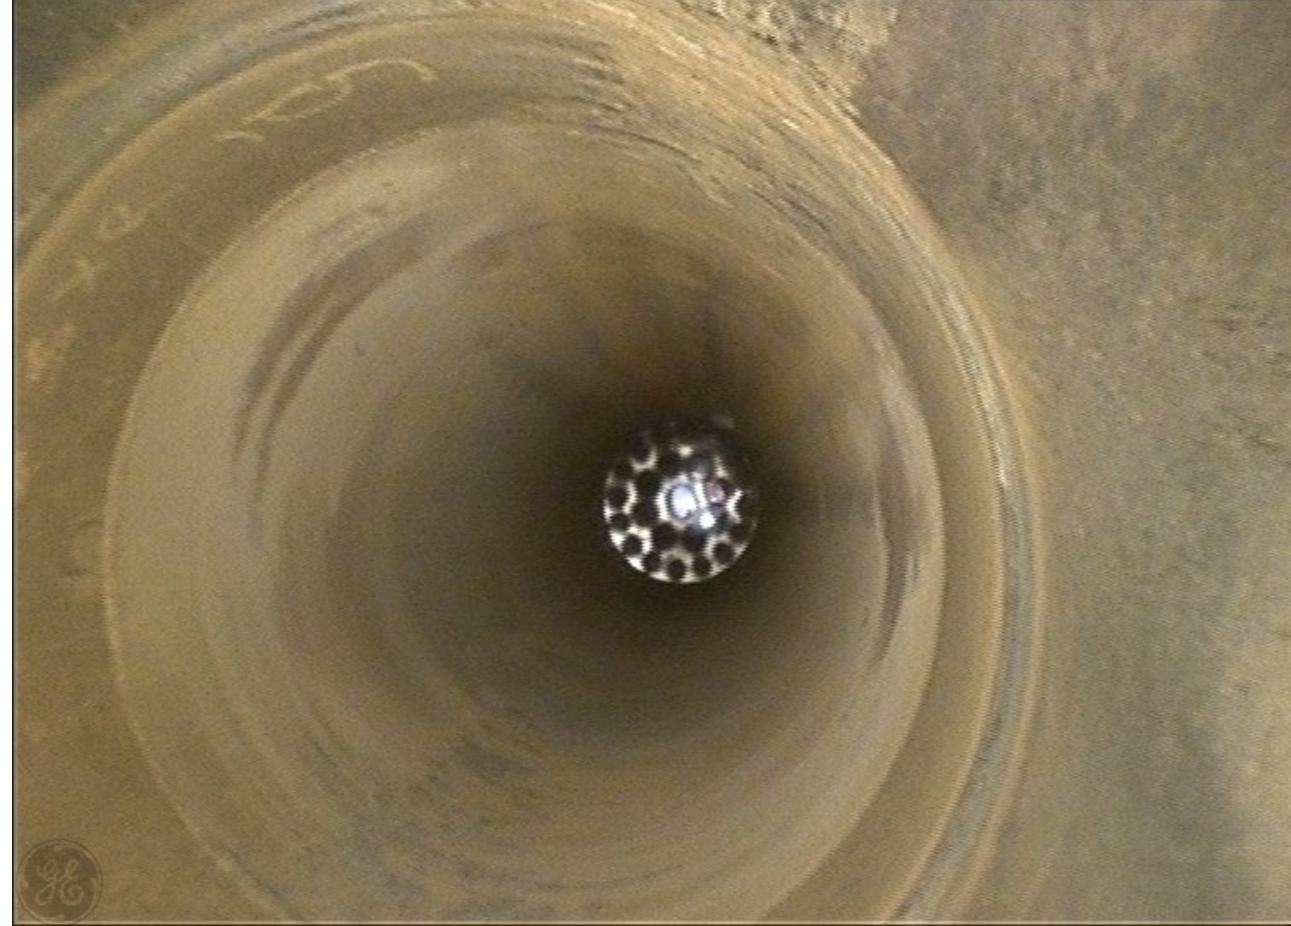
In Field Run Inspection

- Hydrotest water leftover in header caused rust in top of meter

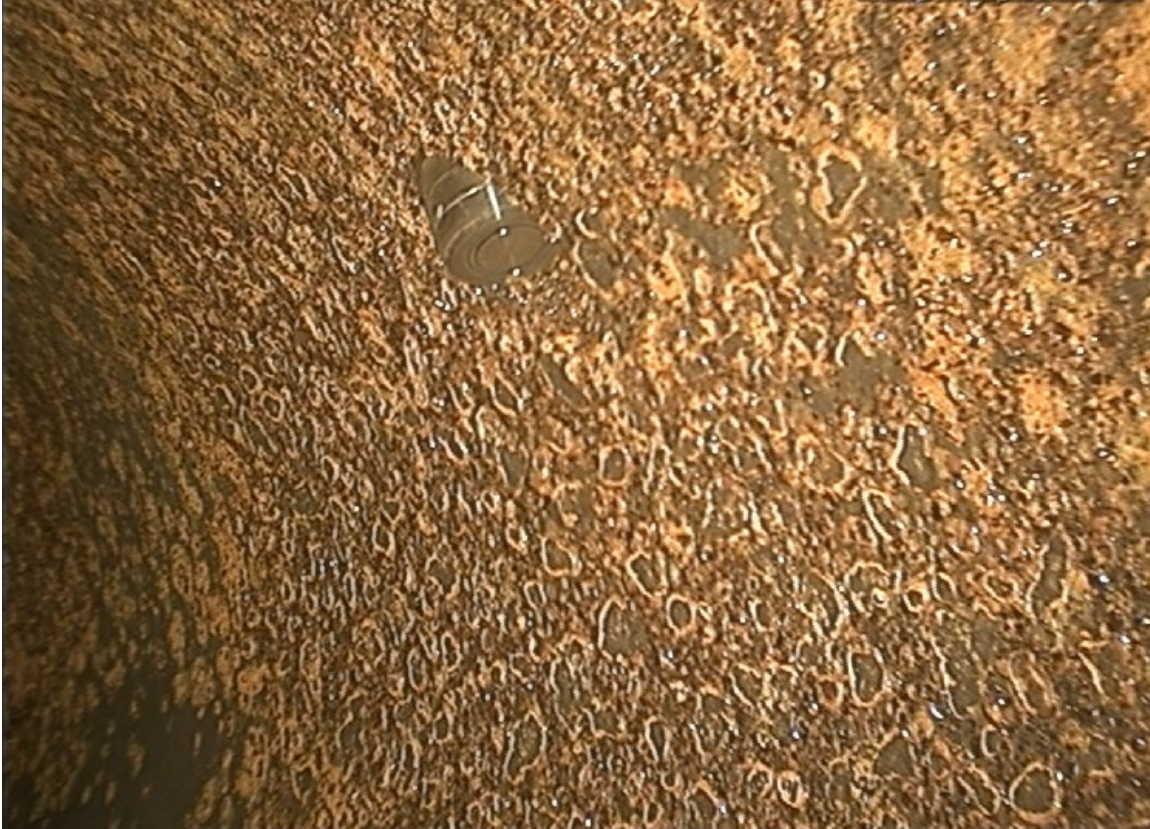
In Field Run Inspection

- **Meter was blown down for an outage and left open to ensure safety (double block & bleed) without notice to Measurement Engineering**

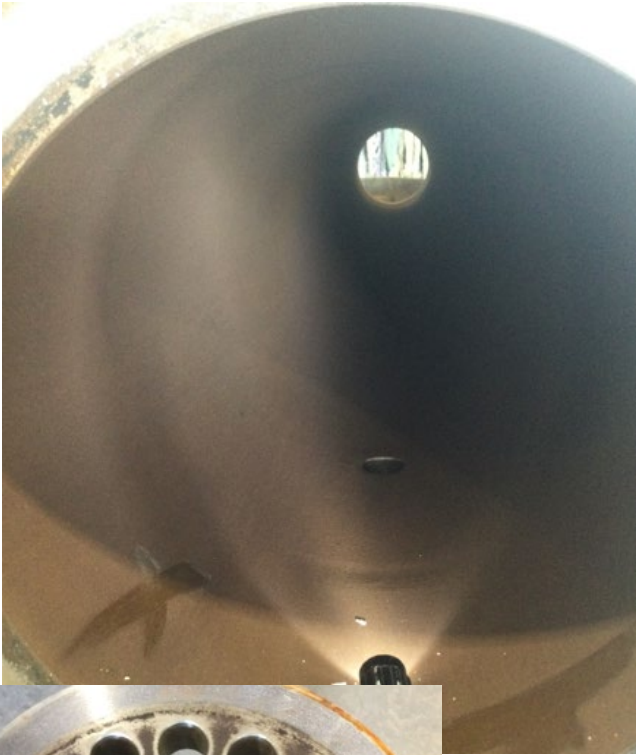
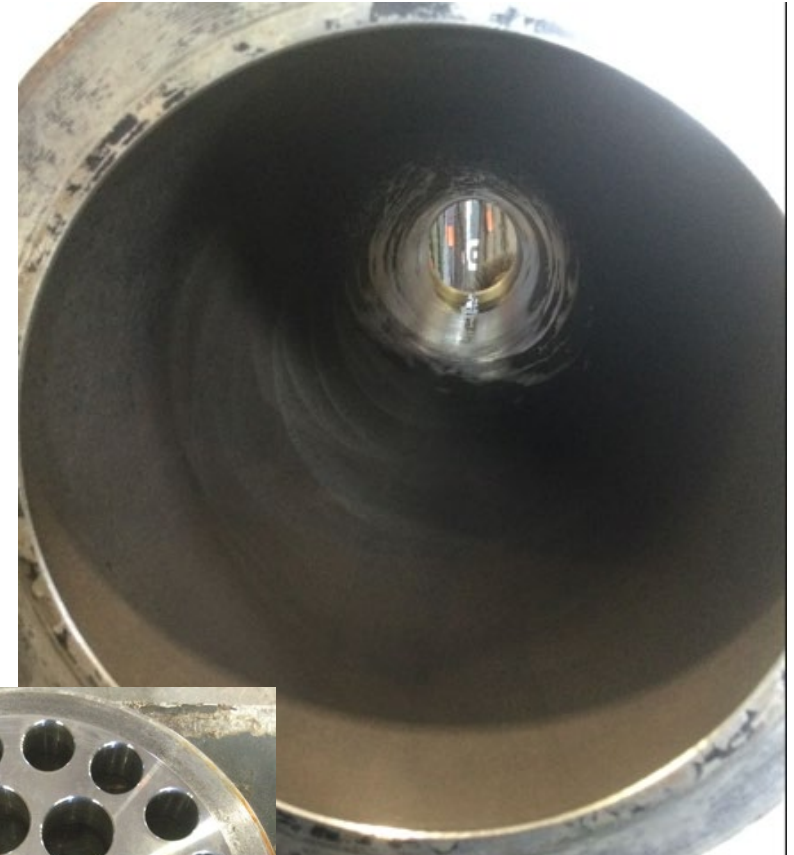
- Cleaned with rags and wire brush
- Thin layer of pipeline dust, evenly distributed
- Same 4 points w/ existing cal factors

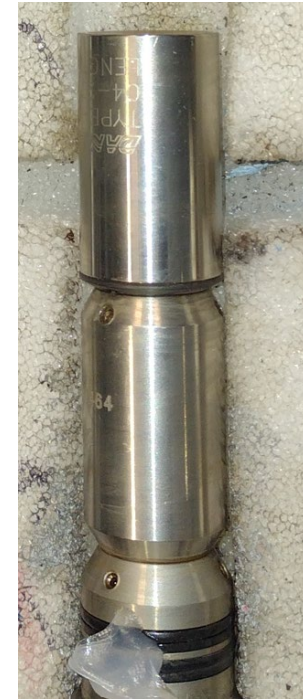
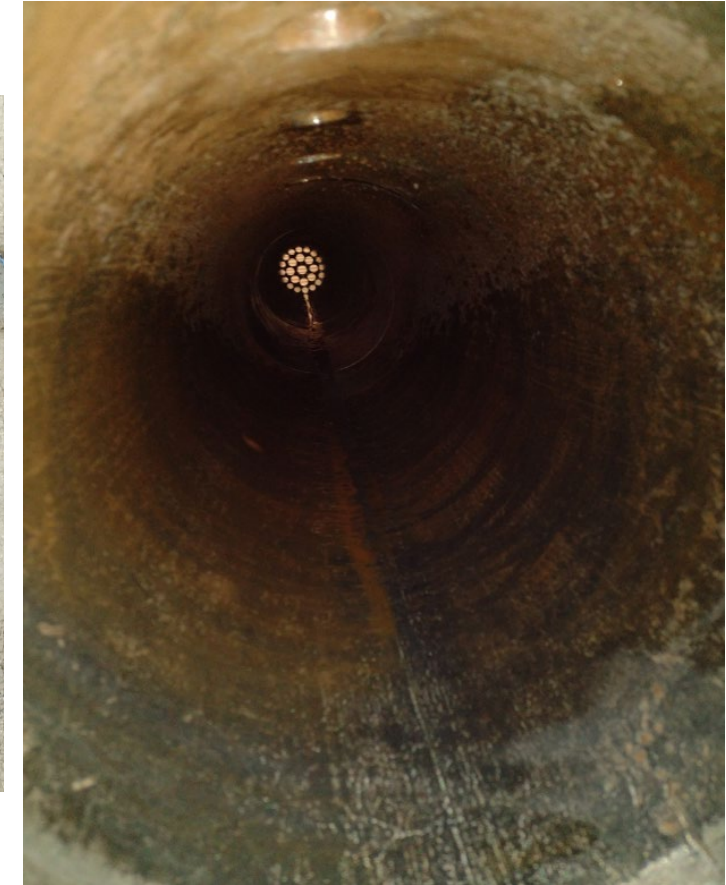
- **Dirty vs. Clean testing completed prior to T-200 transducer install**
- **Meter was largely free of rust, dust, debris. Some discoloration/patina.**
- **Some buildup on transducers & thermowells**

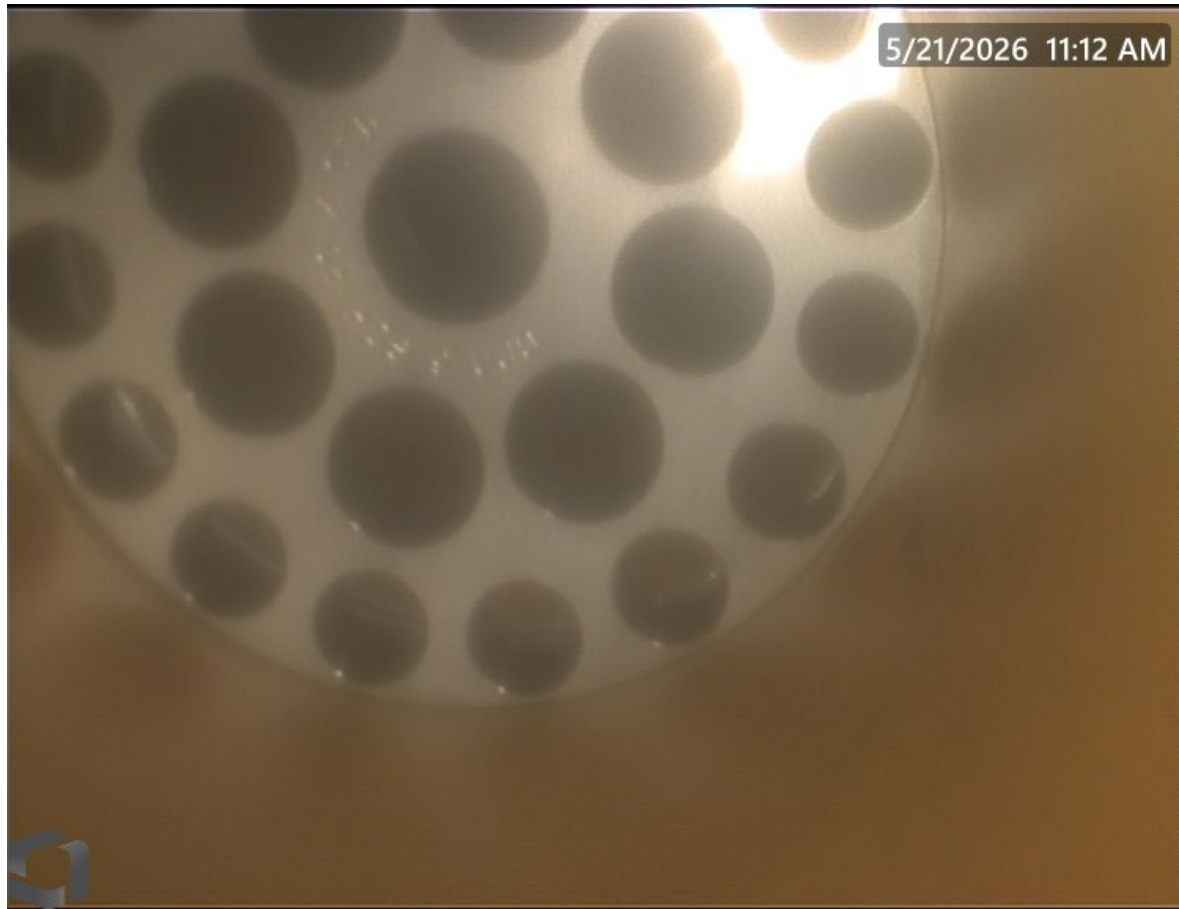
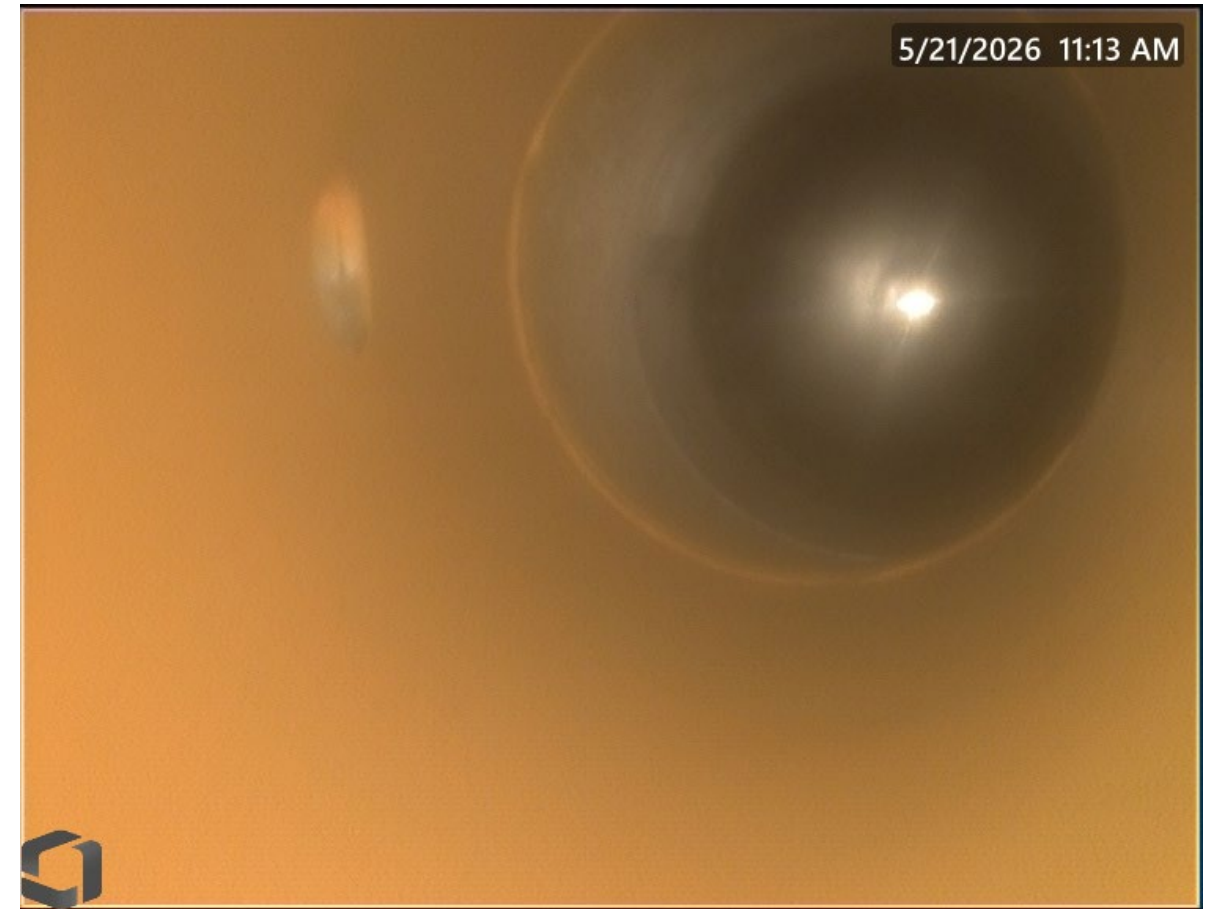
- **Borescope inspection on 5/21/2026 after ~6 months of flow**
  - No signs of contamination & meter diagnostics appear good

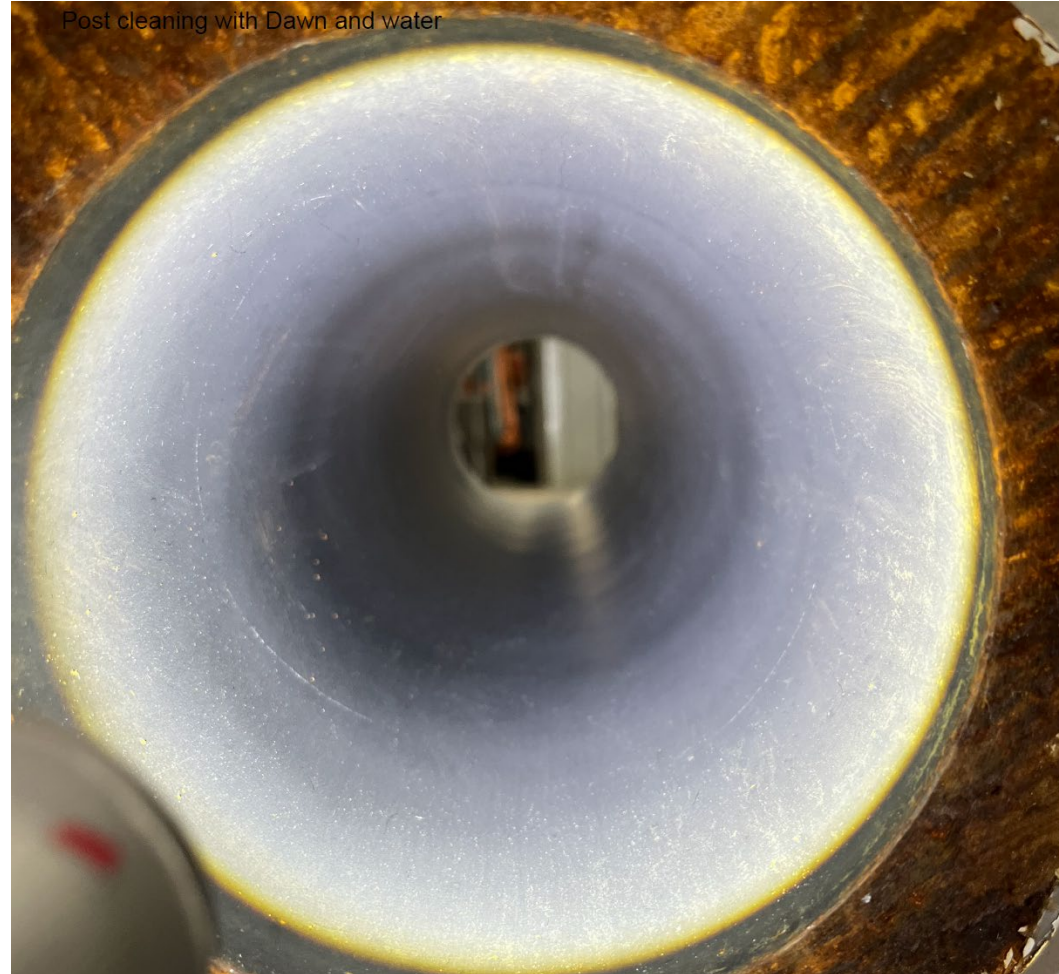
Cerakote spool (black) at end of test period. Post cleaning with Dawn soap & water.

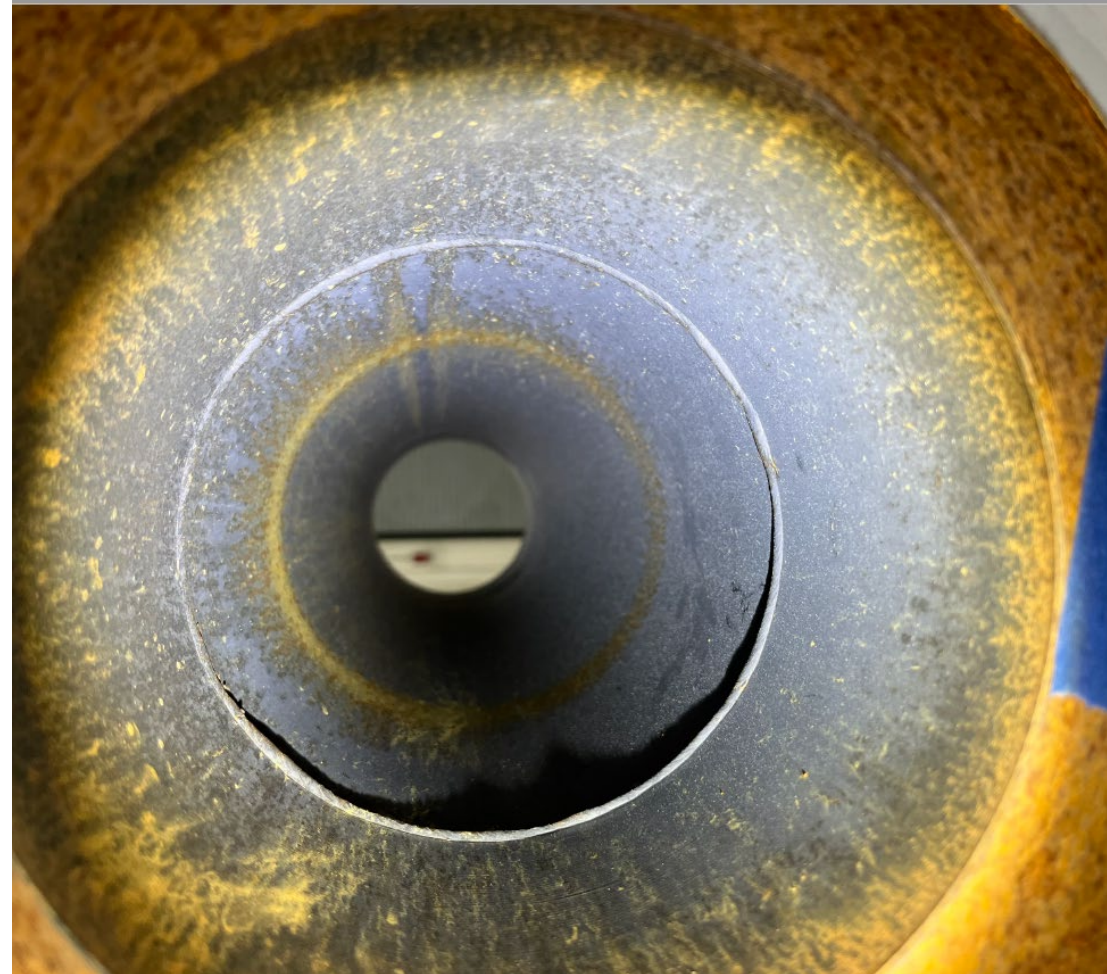
Control spool at end of test period. Post cleaning with Dawn soap & water.

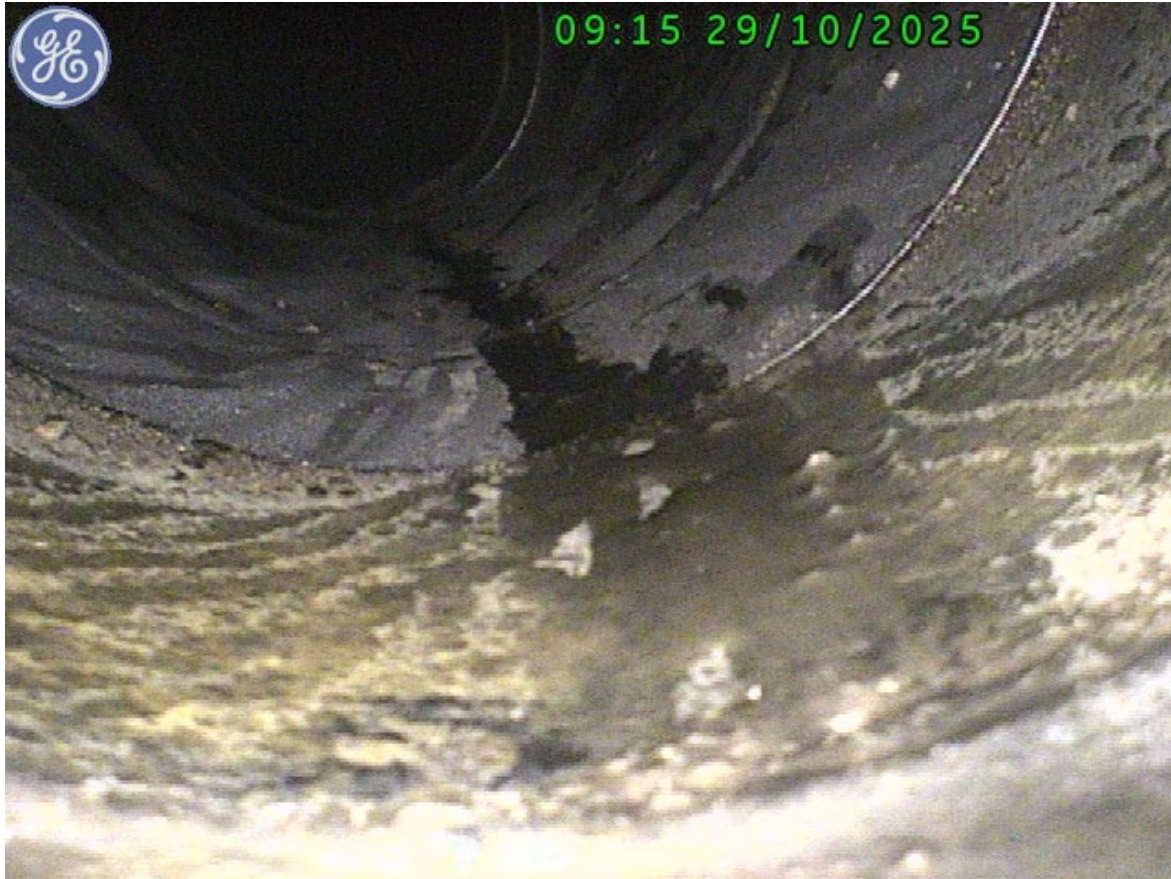
Spool #3 – Cerakote (black) and heat cured. Notice more contamination lingering in the uncoated pipe adjacent to the coated spool.

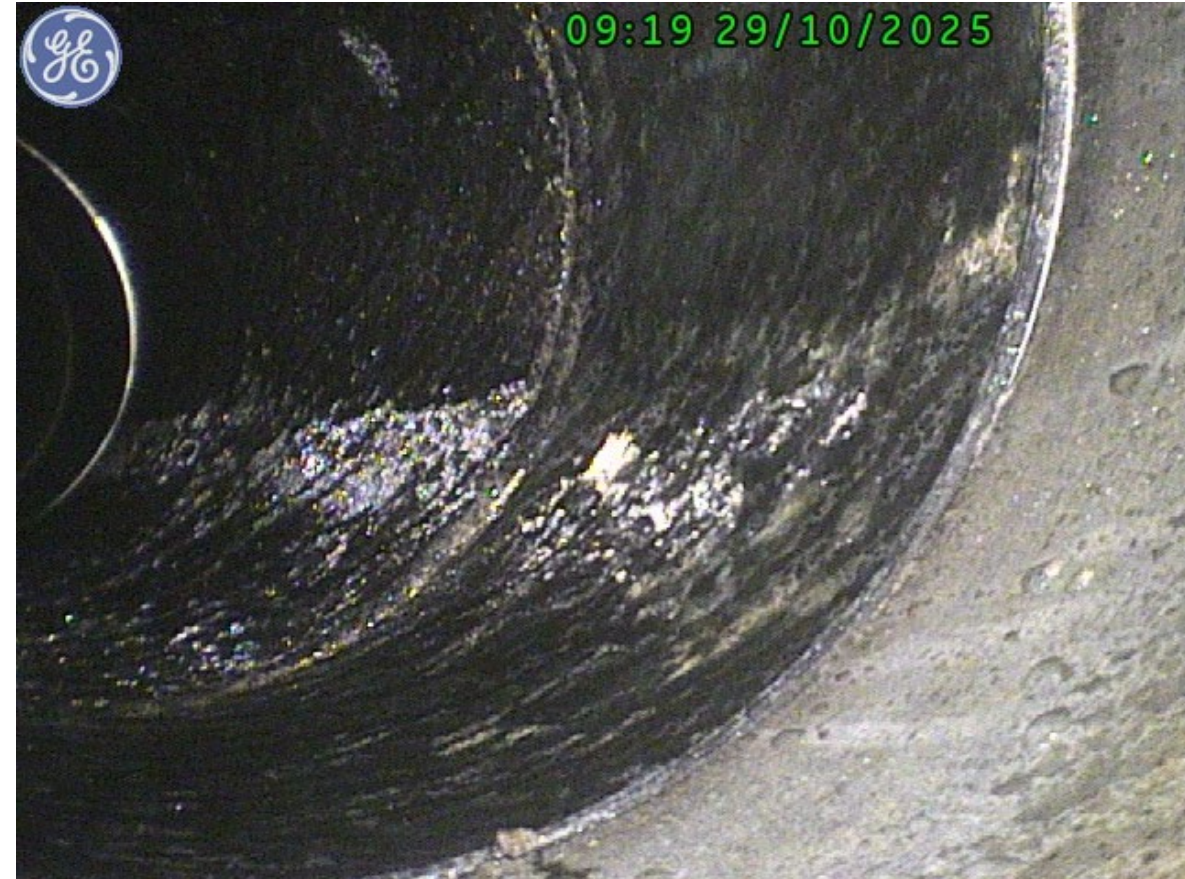
Spool #4 – Control spool uncoated. Typical low grade paint used on flanges/pipe prior to sale & fabrication. Notice the contamination congregating in the uncoated spool.

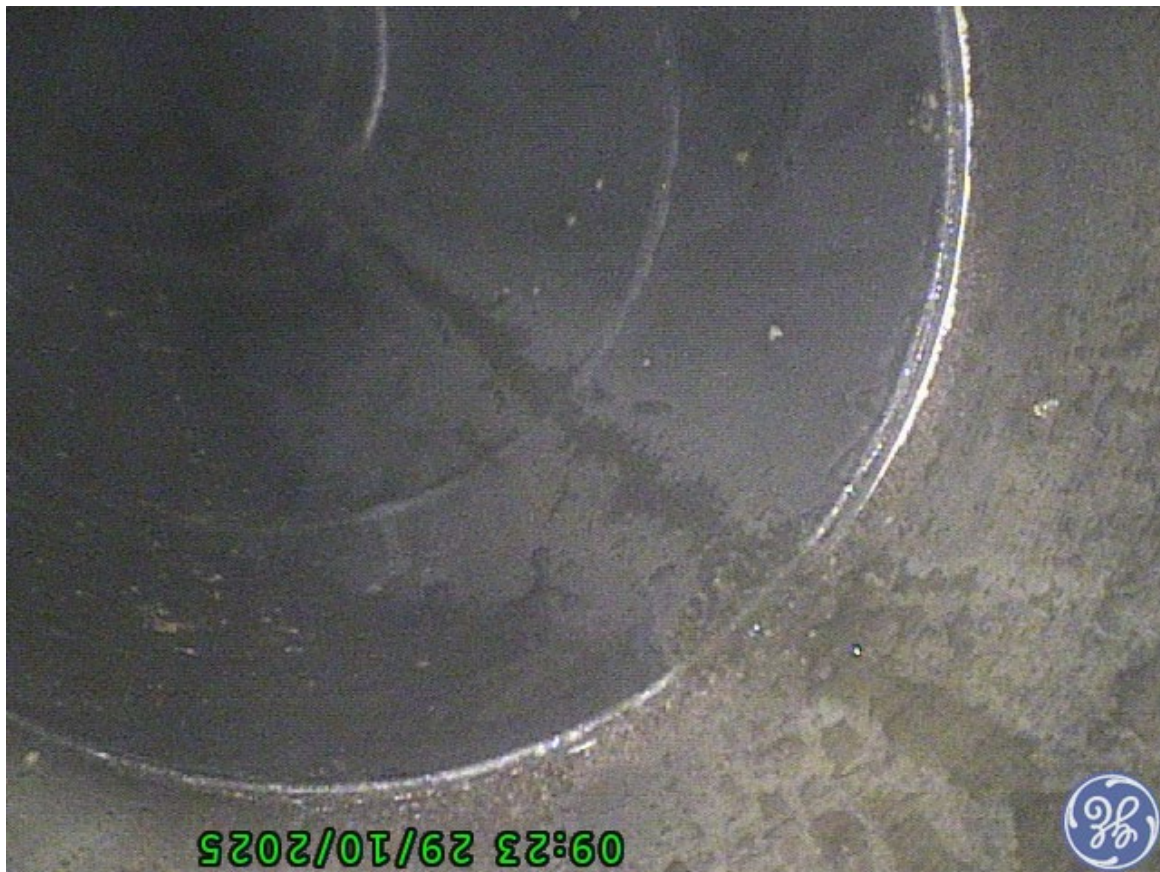
Spool #5 – Cerakote (black) and ambient cured. Notice more contamination lingering in the uncoated pipe adjacent to the coated spool.

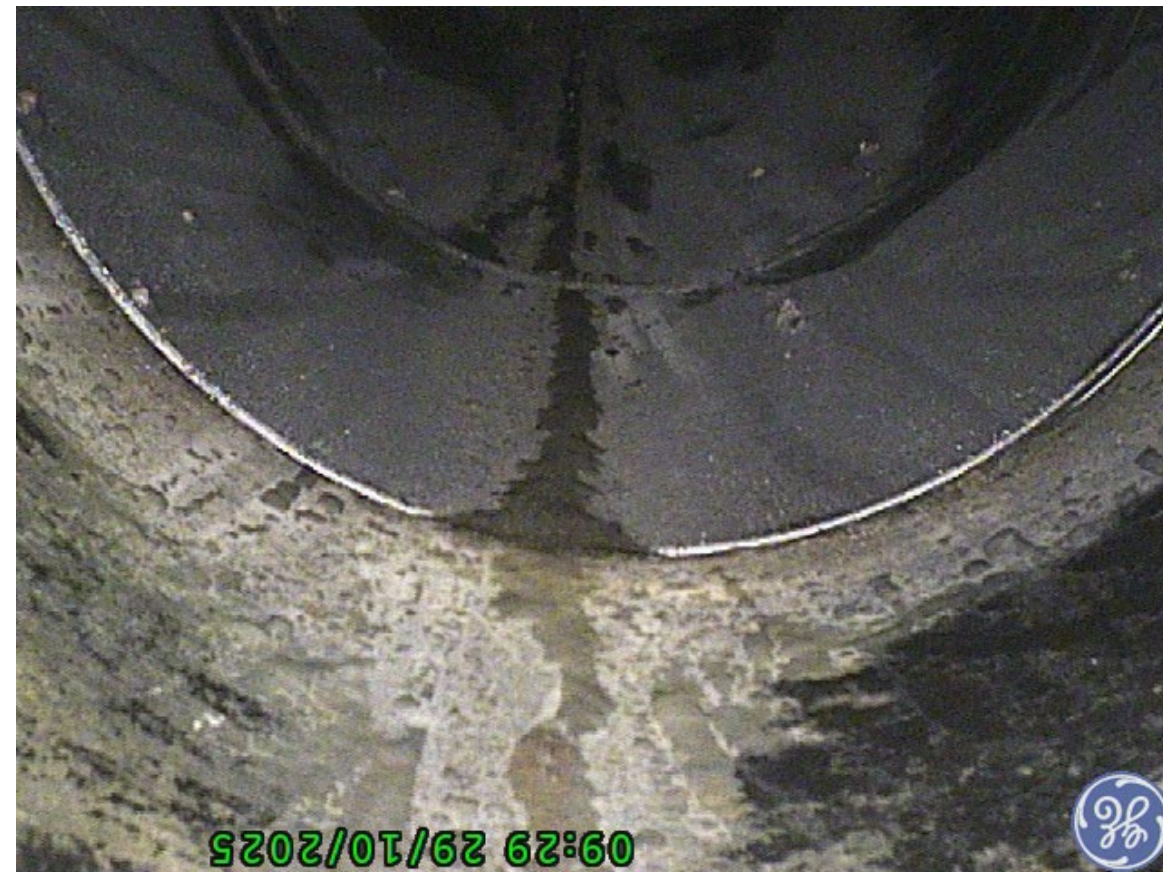
Spool #6 – Cerakote (black) and heat cured. Ball honed after coating to damage the coating.

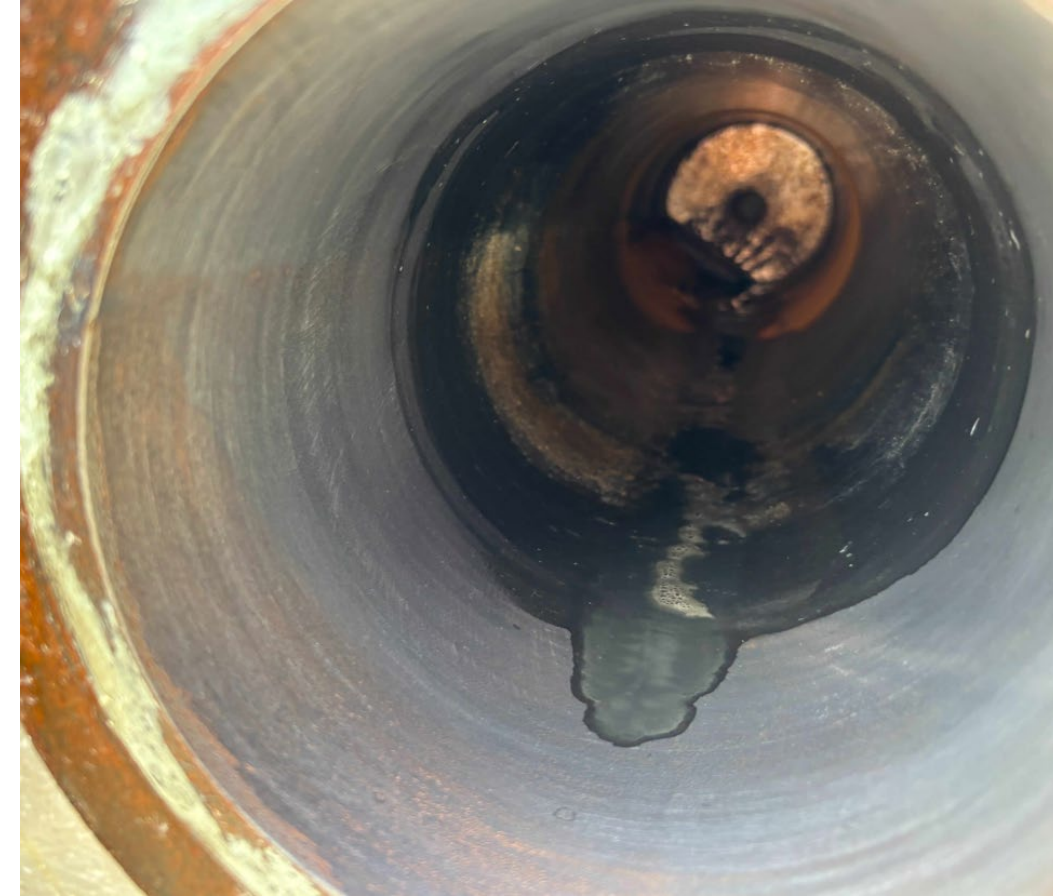
After final wiping by hand. Final condition. Some damage to coating by bare hone.

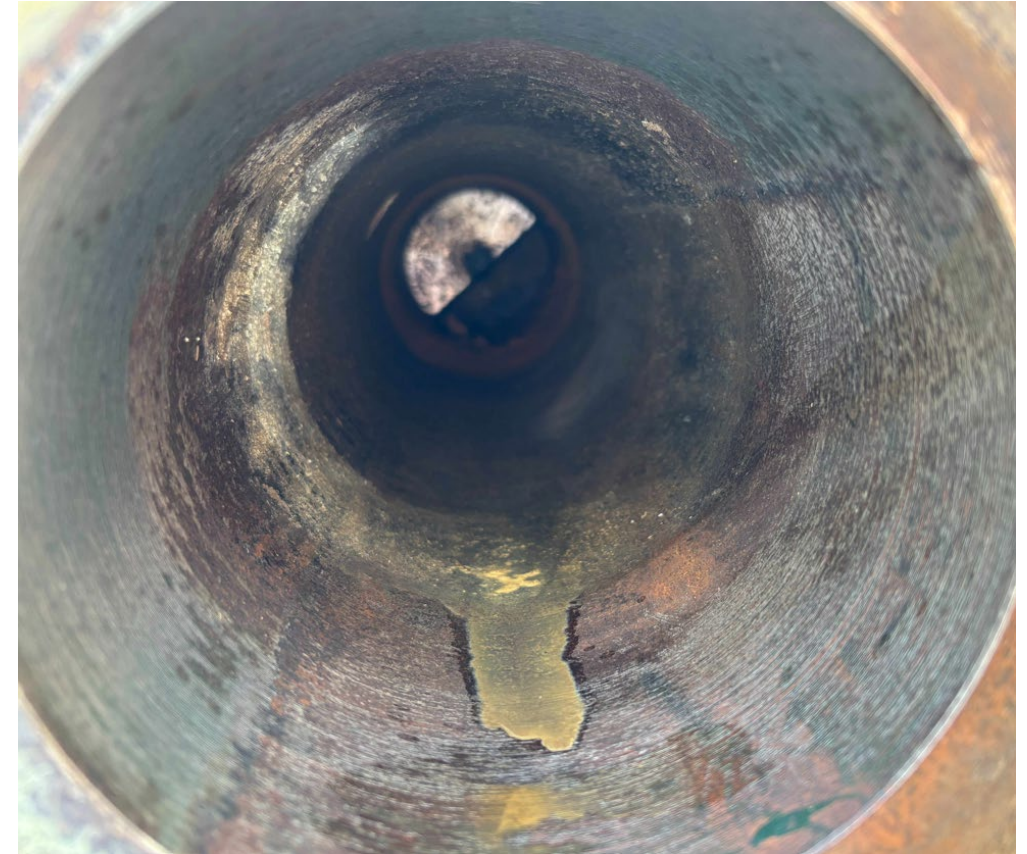
After final wiping by hand. Final condition. Some damage to coating by bare hone.

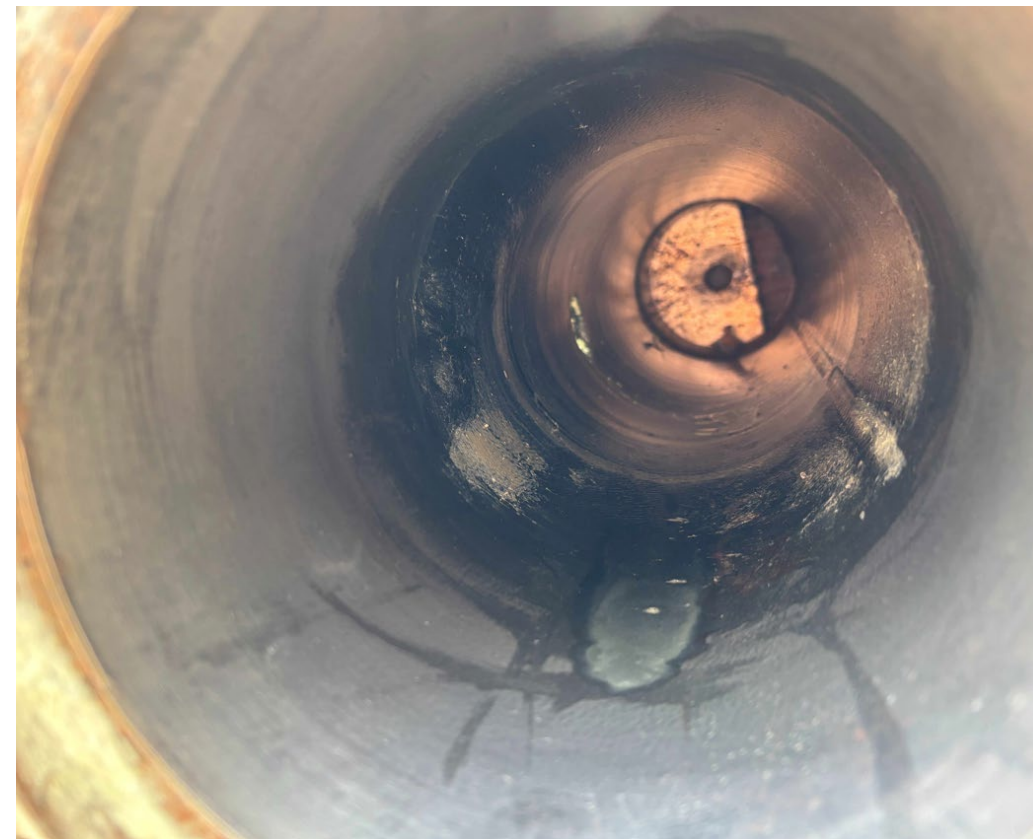
After final wiping by hand. Final condition. Minimal damage to coating by bare hone.

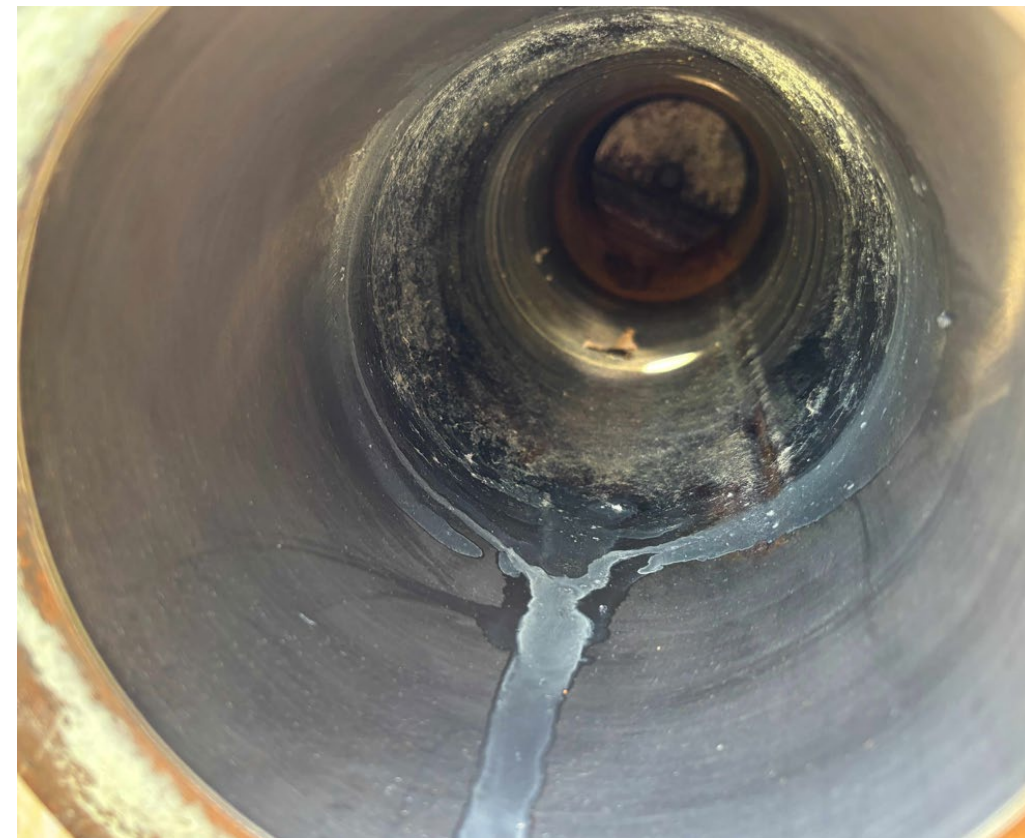
After final wiping by hand. Final condition. Minimal damage to coating by bare hone.

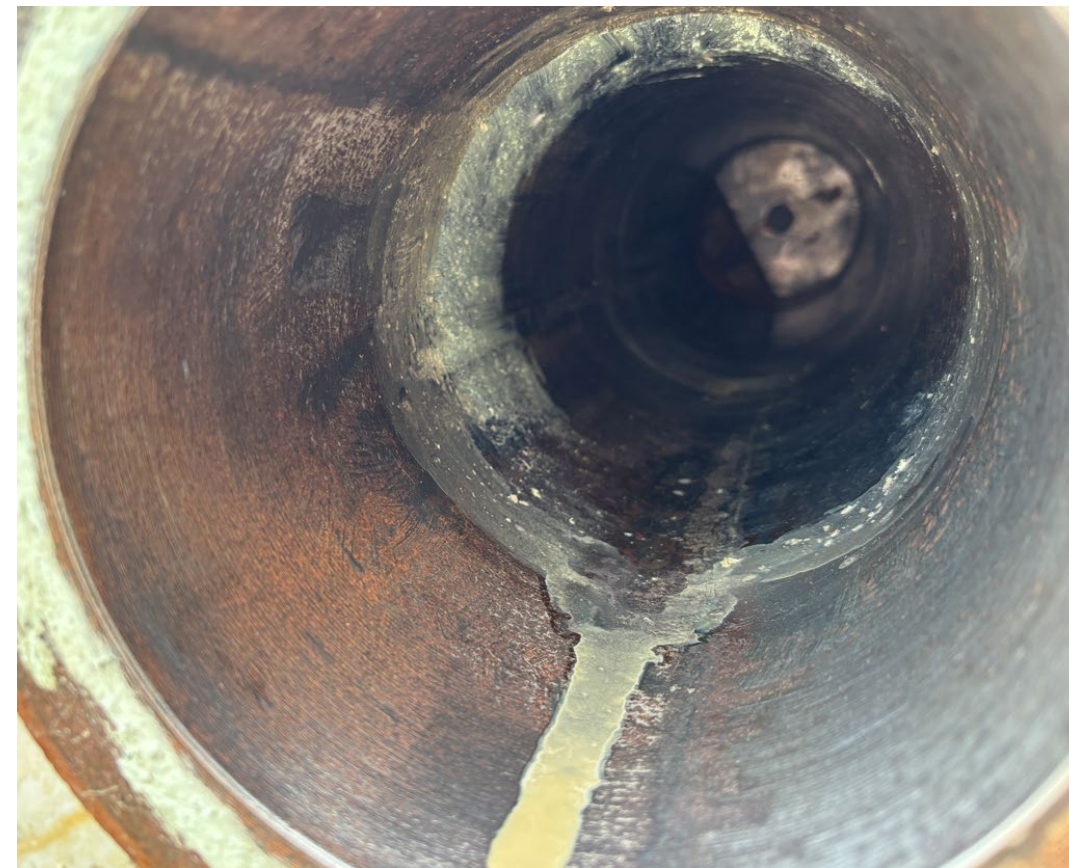
After final wiping by hand. Final condition. Damaged coating & rust showing through.
