# **Meter cleaning & a new internal coating**

June 10, 2026 – CEESI Conference

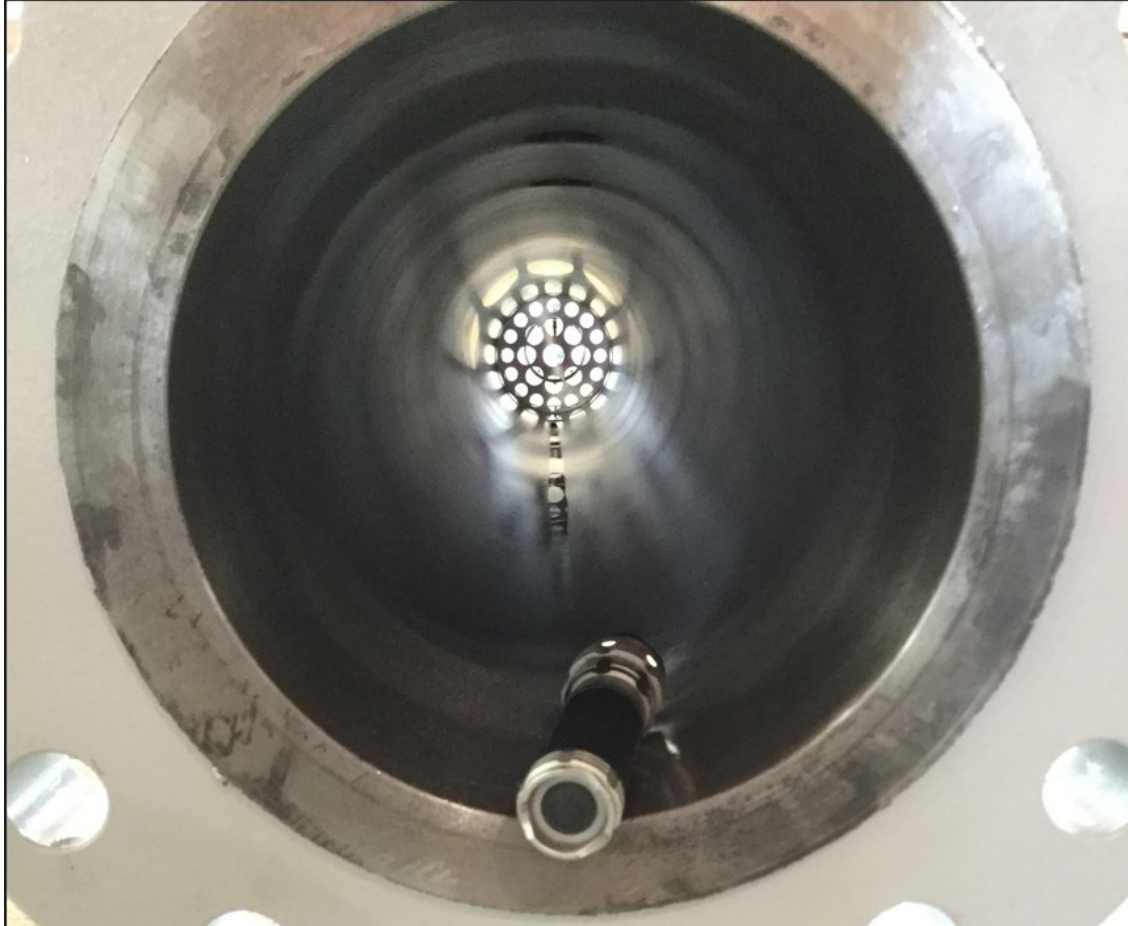
Original Flow Calibration

- Hydrotest water leftover in header caused rust in top of meter

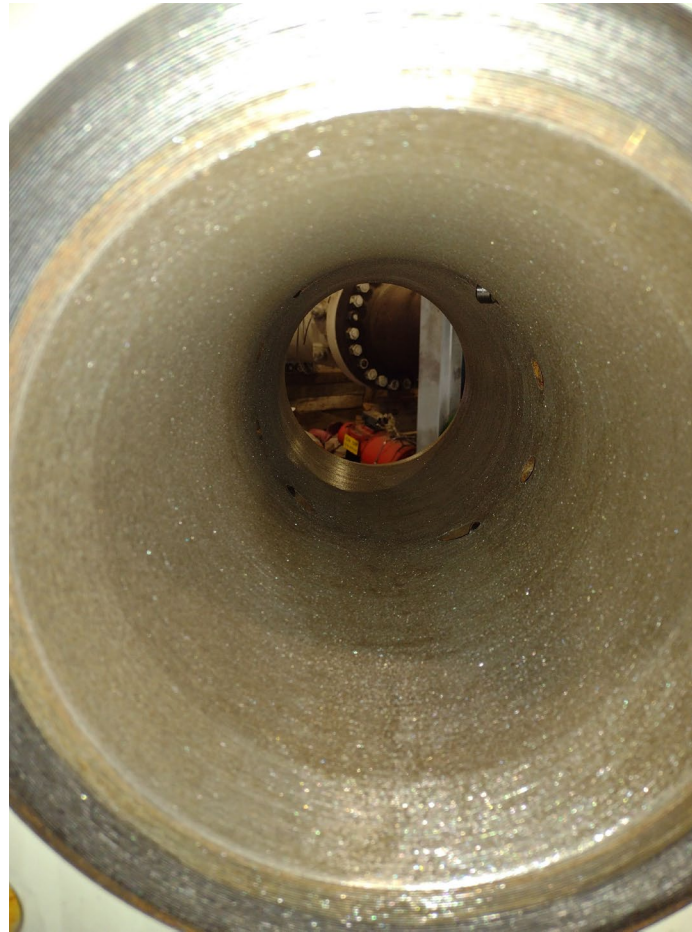
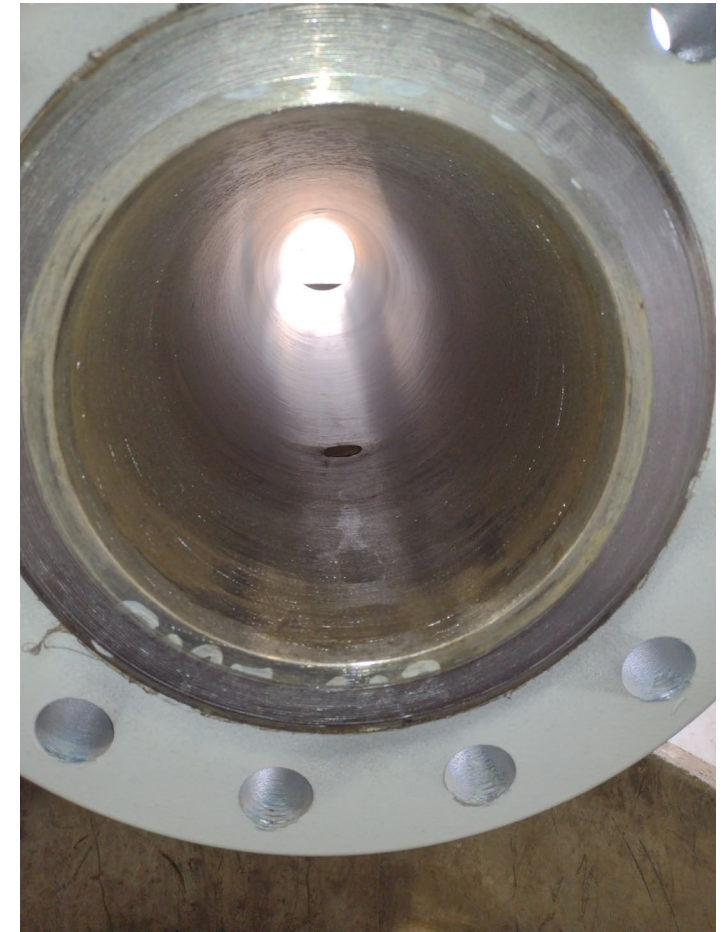
- **Meter was blown down for an outage and left open to ensure safety (double block & bleed) without notice to Measurement Engineering**

- **Meter Tube Disassembled**
- **Transducers Removed, Labeled, and Cleaned**
- **Ball Honed each segment**

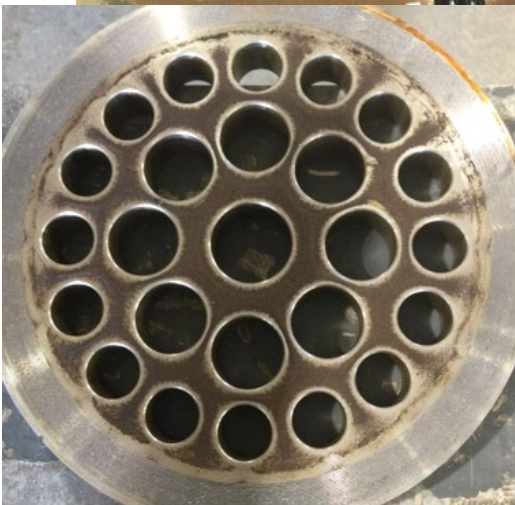
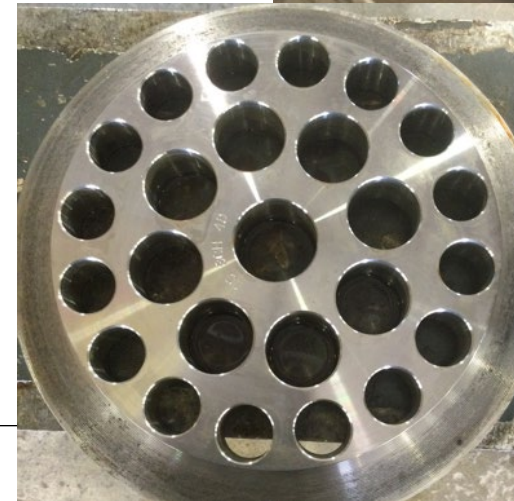
- Cleaned with rags and wire brush
- Thin layer of pipeline dust, evenly distributed
- Same 4 points w/ existing cal factors

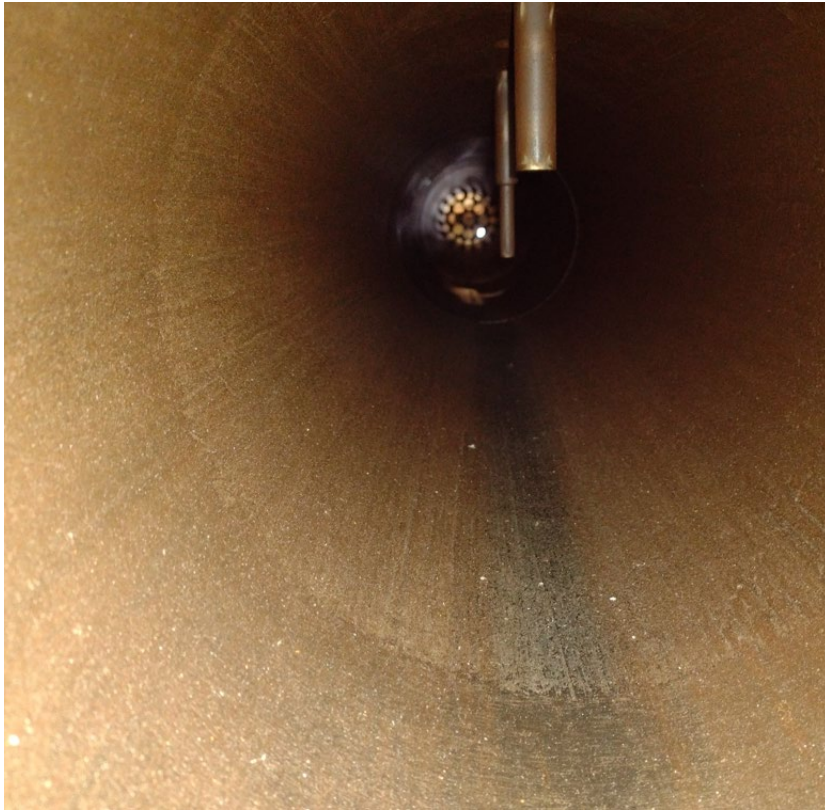
- **Dirty vs. Clean testing completed prior to T-200 transducer install**
- **Meter was largely free of rust, dust, debris. Some discoloration/patina.**
- **Some buildup on transducers & thermowells**

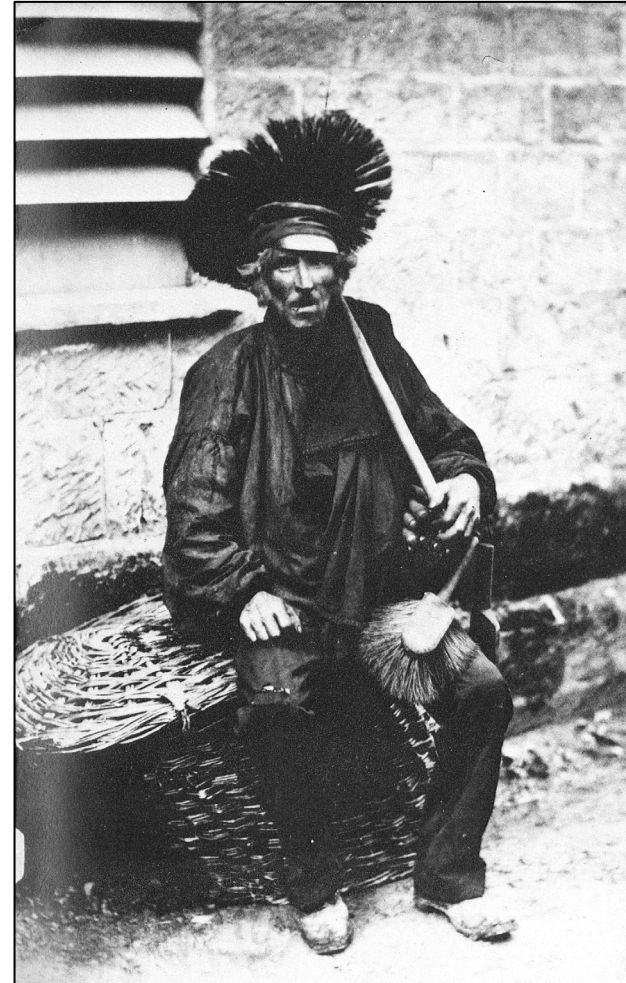
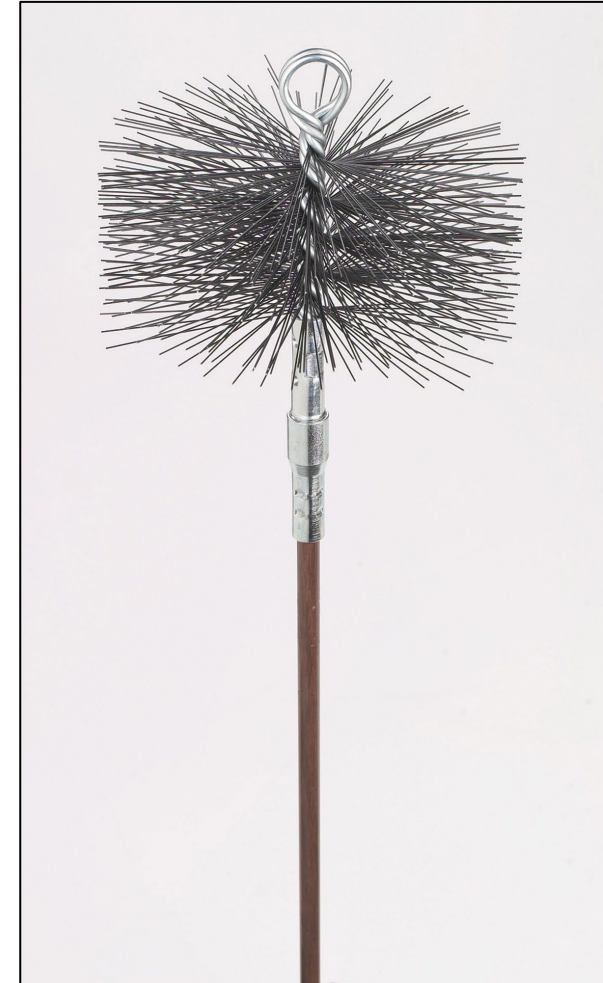
Removal of a piece of poly pig using a grabbing tool with borescope taped to the grabber

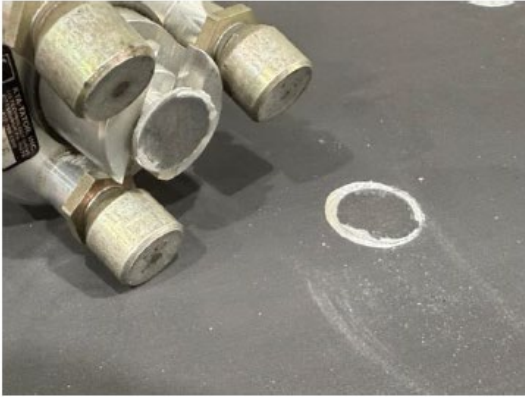
Cohesive Failure

- **Pipeline integrity & internal corrosion concerns**
- **Process to get approval for new coatings**
- **Results show better adhesion than typical pipeline coatings**
  - Plate steel
    - Two samples maxed out at 1000 lb/in<sup>2</sup>
    - One sample had failure at 900 lb/in<sup>2</sup>
  - Wide flange beam
    - two samples maxed out at 1000 lb/in<sup>2</sup>
    - One sample failed at 950 lb/in<sup>2</sup>. Failure of the glue, not the coating

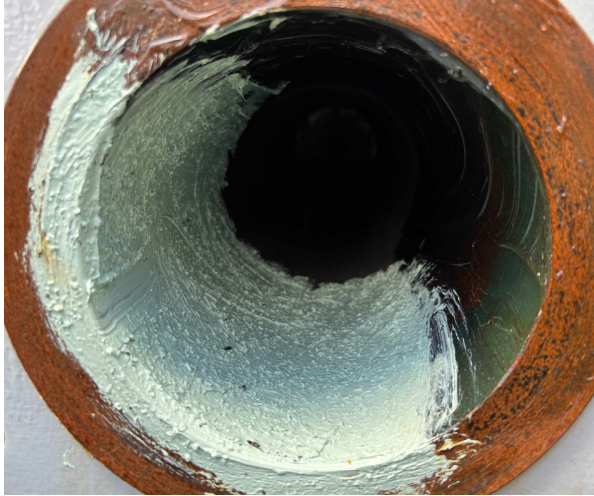
Grease & sealant added

- **Spool #7 – Control spool, no coating**

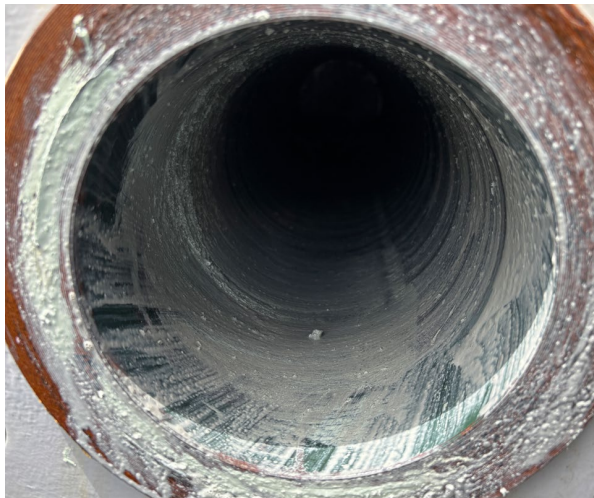
After 1<sup>st</sup> ball hone cleaning. Hone covered by towel & degreaser used.

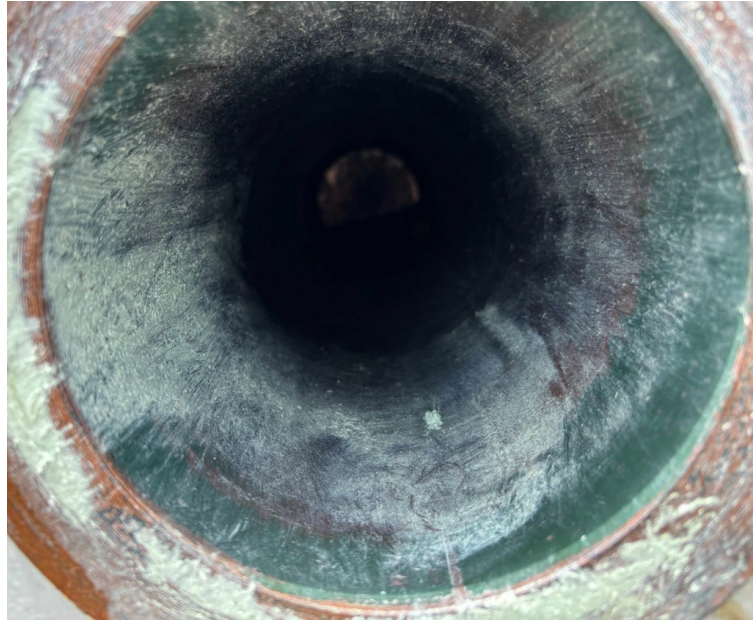
After 2<sup>nd</sup> ball hone cleaning. Hone was bare & degreaser used.

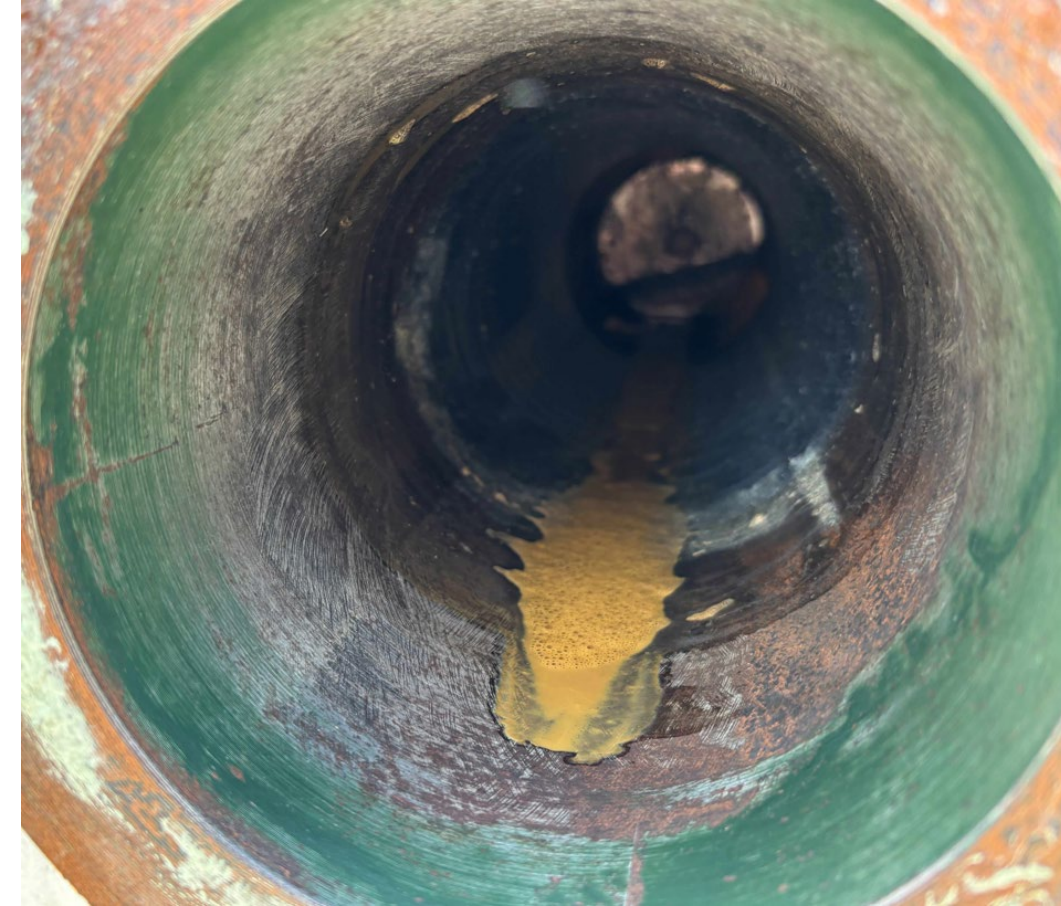
After final wiping by hand. Final condition.

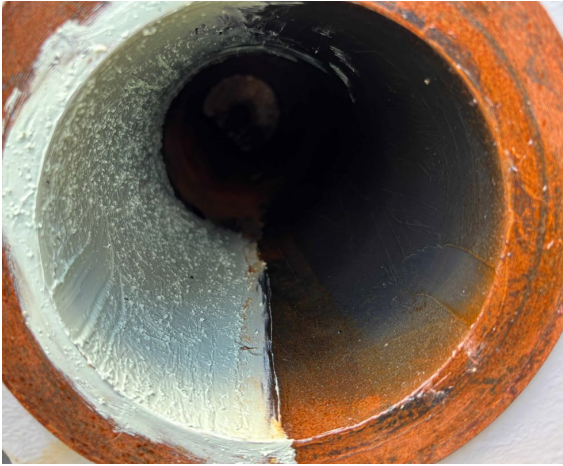
Grease & sealant added

- **Spool #8 – Cerakote, heated 120F cure**

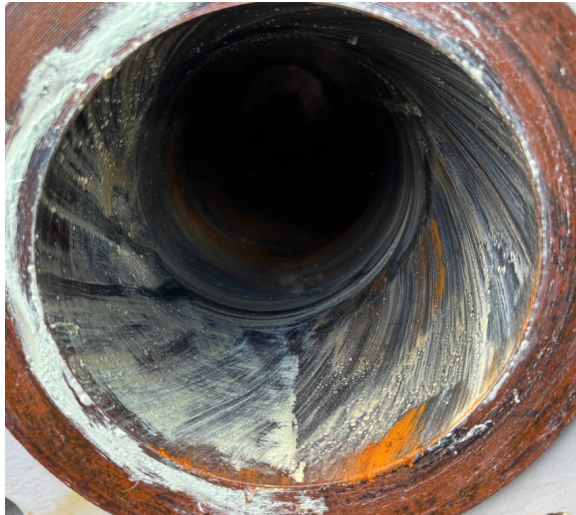
After 1<sup>st</sup> ball hone cleaning. Hone covered by towel & degreaser used.

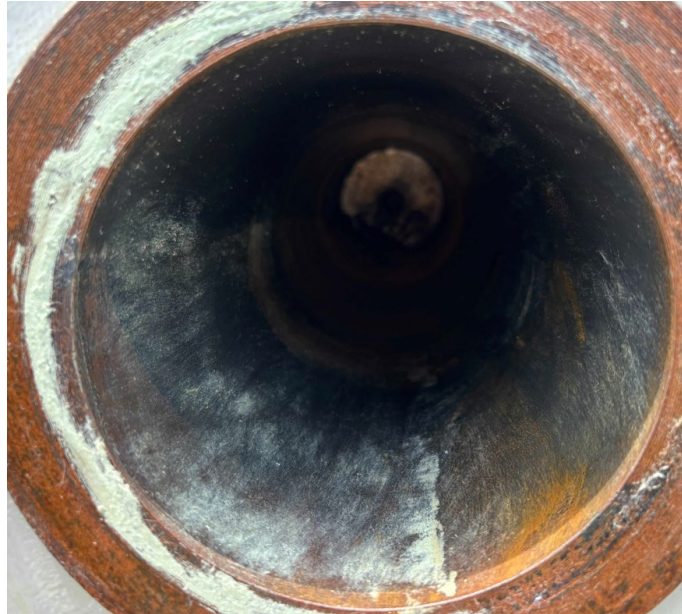
After 2<sup>nd</sup> ball hone cleaning. Hone was bare & degreaser used.

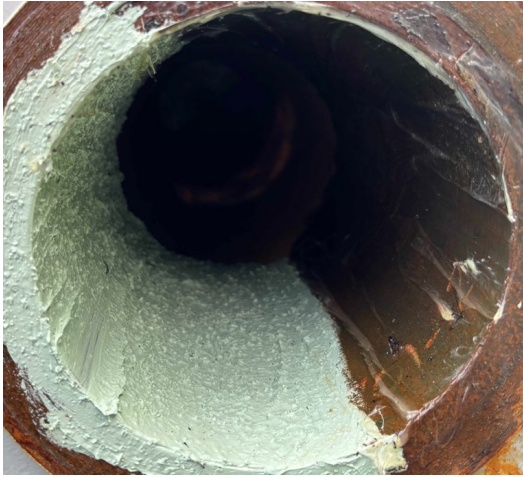
Grease & sealant added

- **Spool #9 – No Cerakote, control spool**

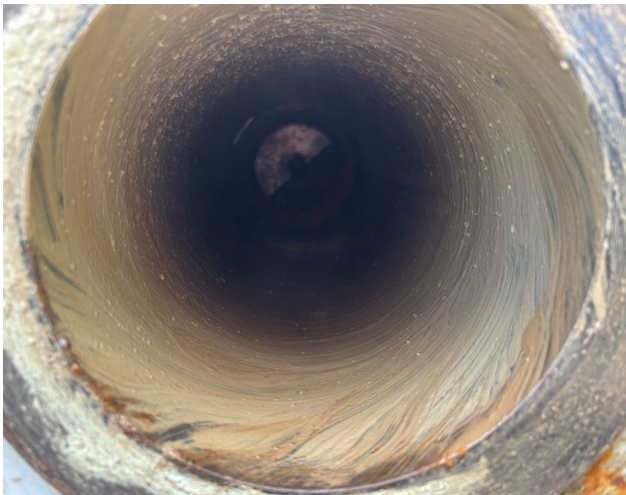
After 1<sup>st</sup> ball hone cleaning. Hone covered by towel & degreaser used.

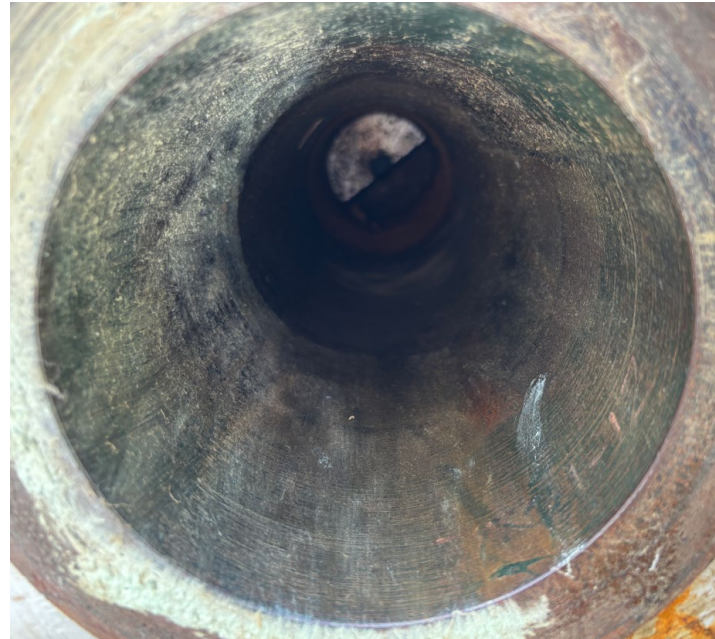
After 2<sup>nd</sup> ball hone cleaning. Hone was bare & degreaser used.

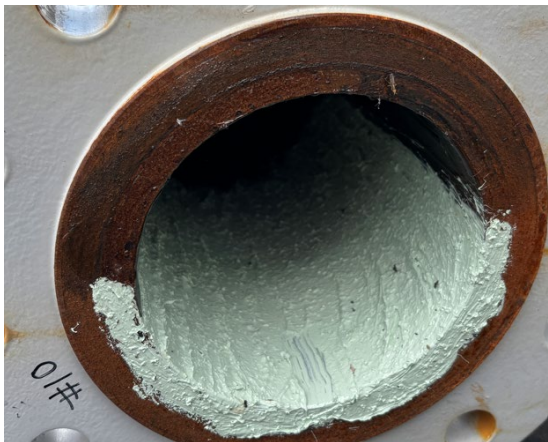
Grease & sealant added

- **Spool #10 – Cerakote, heated 120F cure**

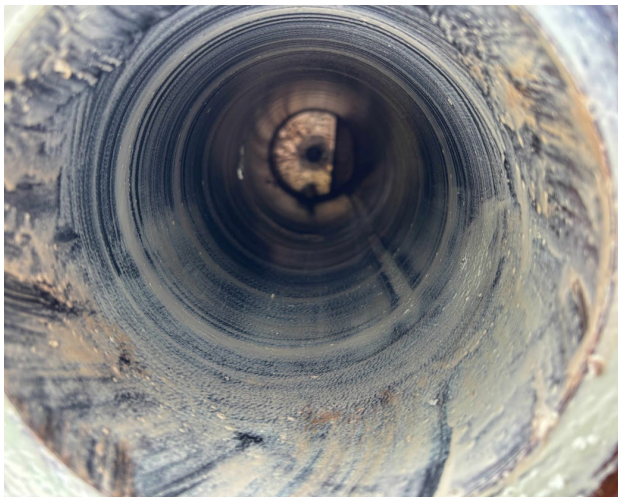
After 1<sup>st</sup> ball hone cleaning. Hone covered by towel & degreaser used.

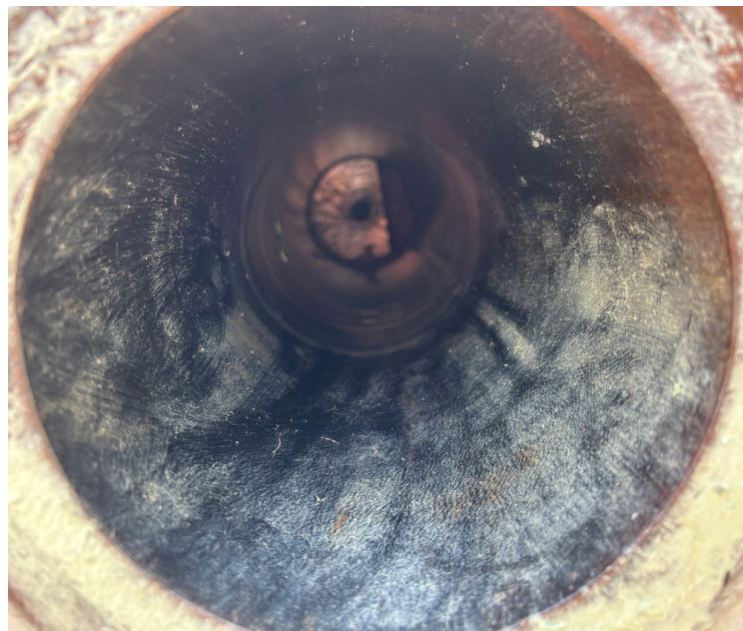
After 2<sup>nd</sup> ball hone cleaning. Hone was bare & degreaser used.

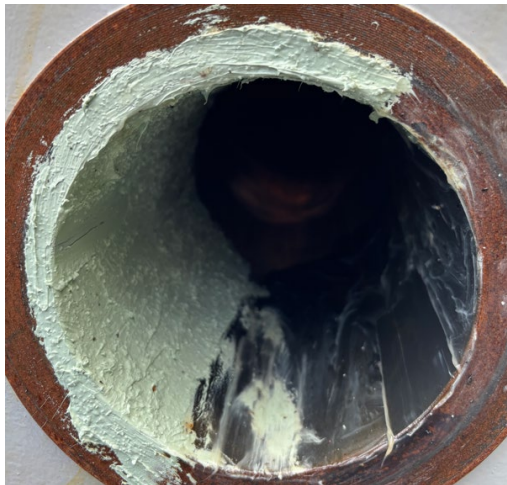
Grease & sealant added

- **Spool #11 – Cerakote, ambient cure**

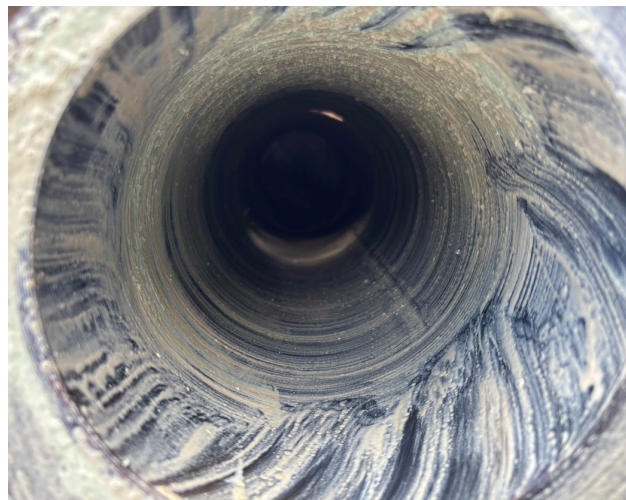
After 1<sup>st</sup> ball hone cleaning. Hone covered by towel & degreaser used.

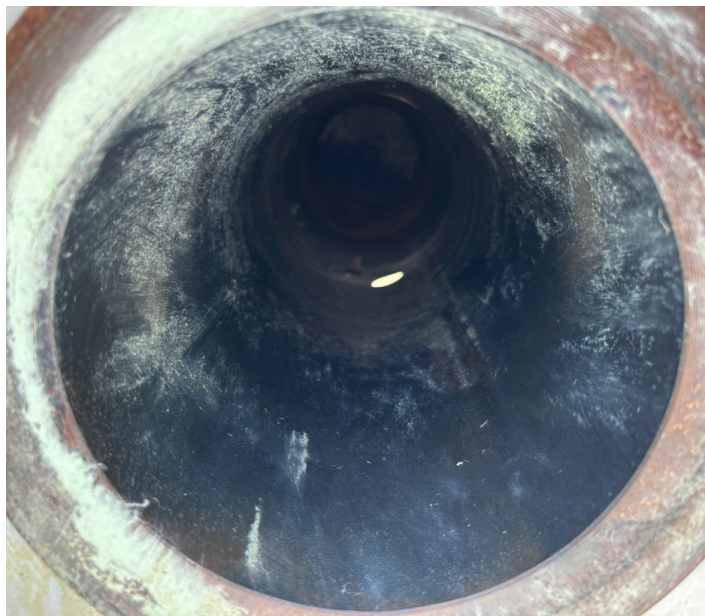
After 2<sup>nd</sup> ball hone cleaning. Hone was bare & degreaser used.

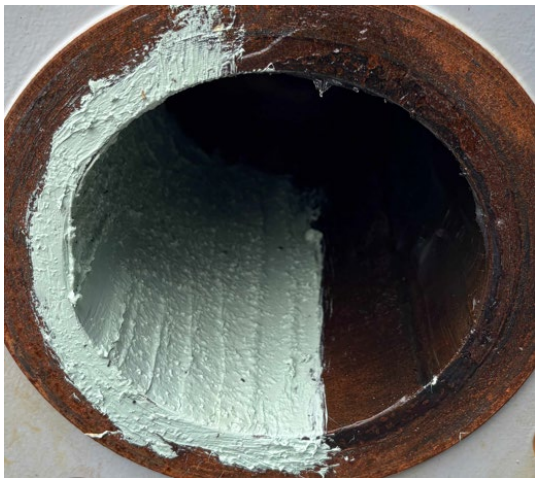
Grease & sealant added

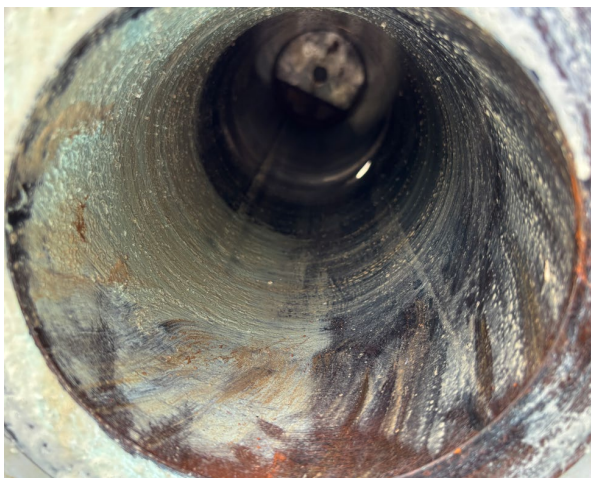
After 1<sup>st</sup> ball hone cleaning. Hone covered by towel & degreaser used.

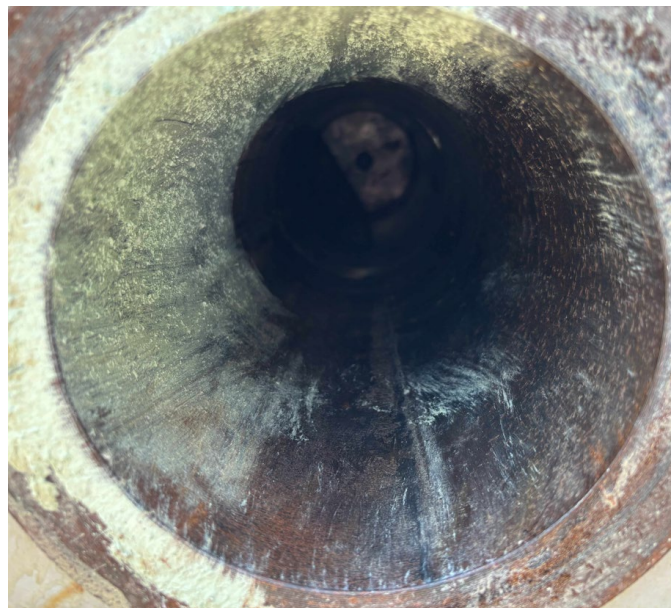
After 2<sup>nd</sup> ball hone cleaning. Hone was bare & degreaser used.
